# **Zoo Project Executed on SDS2 Software**

Our project that featured in "Modern Steel Construction 2022" Magazine

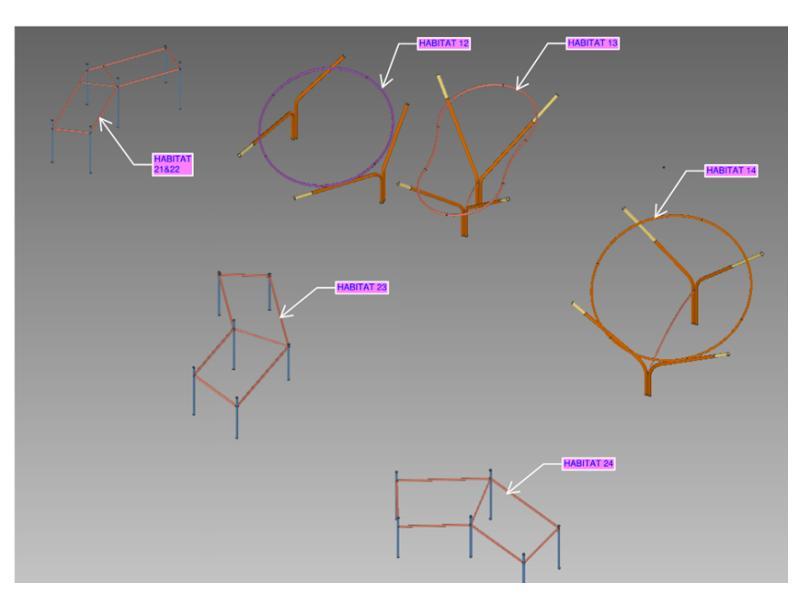
- The project had to be detailed in SDS model, that had foundational piers set at coordinates as per the existing conditions. We had to match/coordinate those with the design drawings for the location and elevations.
- Dimension and elevation of the columns, and rings could not be obtained in the model for the three largest habitats.

- We brainstormed as a team and came up with the best assumptions that could be made. Later, the prepared assumptions led us to easy approval of the drawings by the client.
- We took a different approach here, the ring being the most critical part of the habitat was finalized first using the design drawing elevation. A top down approach was followed in the habitat detailing. Where the topmost steel was finalized first, followed by the connection points, the degree and orientation of bent HSS columns, then by a split base plate.
- We also took a trial and error approach here, it was done to get a best geometrical fit for the habitats. A lot of adjustments in the dimensions, degree of bends, slopes and elevations were made to obtain a best fit, and these were approved by the design team in the submittals.

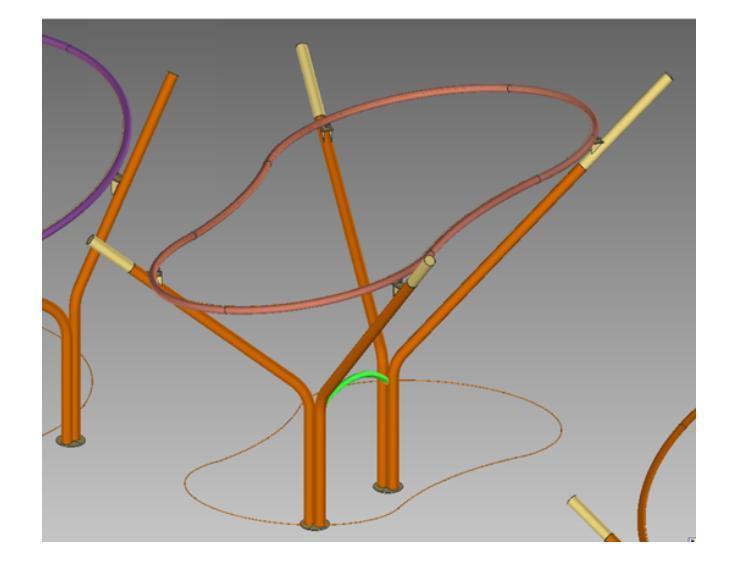
- Connecting the ring to column ball bearing connection detail. This was the most crucial connection. The connection could not be made unless the geometry is perfect for the rotation and orientation. Also a software limitation to add the solid steel sphere/ball in SDS, without which the connection could not be visualized.
- Considering all the challenges, several testing had to be done before we conclude. We took an out-of-the box approach and tested to model a sphere. A square steel cube was cut in a circle at several rotations to get a nearly perfect sphere (Image below).
